# Manhole Inspection Summary

Manhole # S21K1\_025MH

Insp Date: **4/25/08 11:23 AM**

**Location** Address: **2618 stranden rd**

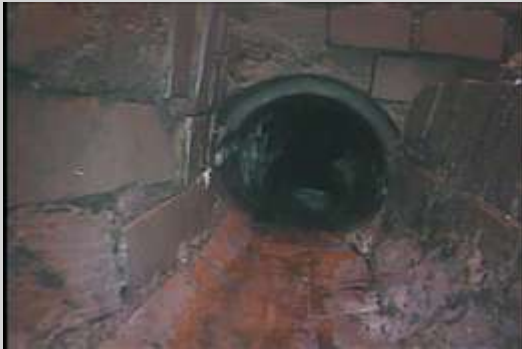
12 O'Clock Outflow

Pipe Height: **8.4** (in.) Rod and Bar (Angled)  
Pipe Material: **Clay** ☐ Pipe Lined  
Invert Depth: **10.25** (ft.) Flow Characteristics: **Slow**  
Deposits: ☒ None ☐ Mud ☐ Sludge ☐ **Debris** ☐ Grease  
Silt Depth: **0** (in.) Deposits Extent:  
Infiltration: **None** Pipe Seal Cond: **Sound**

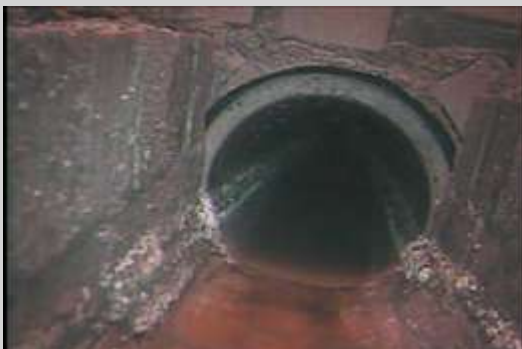
6 O'Clock Inflow

Pipe Height: **8.4** (in.) Rod and Bar (Angled)  
Pipe Material: **Clay** ☐ Pipe Lined  
Invert Depth: **9.93** (ft.) Flow Characteristics: **Slow**  
Deposits: ☒ None ☐ Mud ☐ Sludge ☐ **Debris** ☐ Grease  
Silt Depth: **0** (in.) Deposits Extent:  
Infiltration: **None** Pipe Seal Cond: **Sound**
